AFML-TR-78-160
Volume II

COST EFFECTIVE REPAIR TECHNIQUES FOR TURBINE AIRFOILS

GENERAL ELECTRIC COMPANY

APRIL 1979

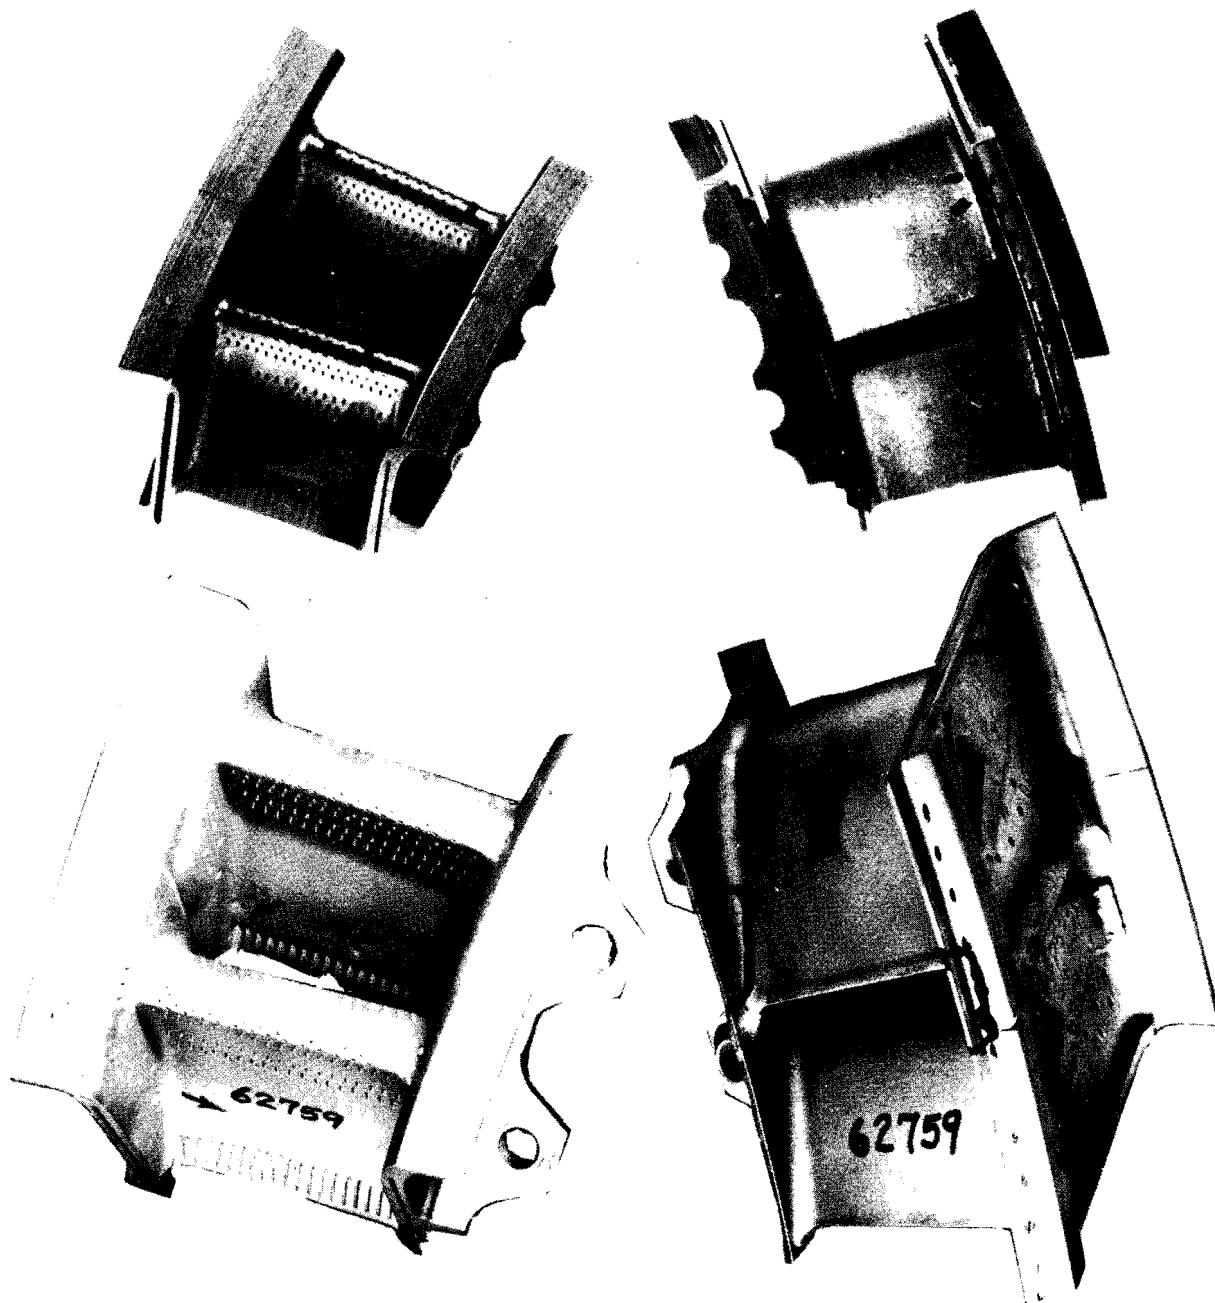
Figure 7. Stage 1 HPTV, S/N 62759, Before ADH Repair and After 1000 Cycle Engine Test Showing Successful ADH Repair

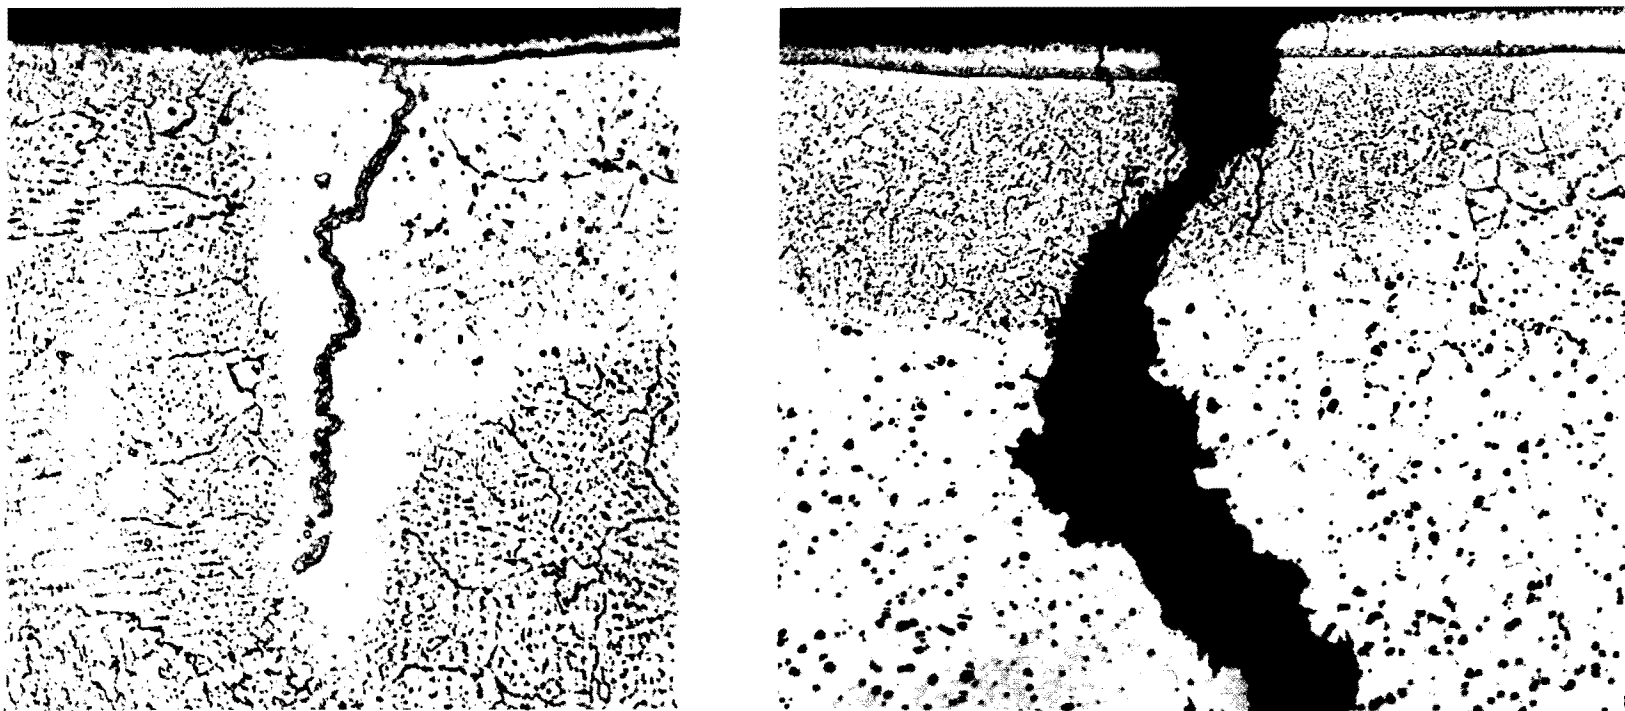
LEFT: SUCCESSFUL ADH REPAIR OF PRIOR WELD CRACK IN AREA A
RIGHT: ENGINE INDUCED CRACK OF WELD REPAIR IN AREA B

Figure 9. Microphotographs of Sections From Area A and B of Stage 2 HPTV, S/N 54954
After 1000 Cycles Engine Test

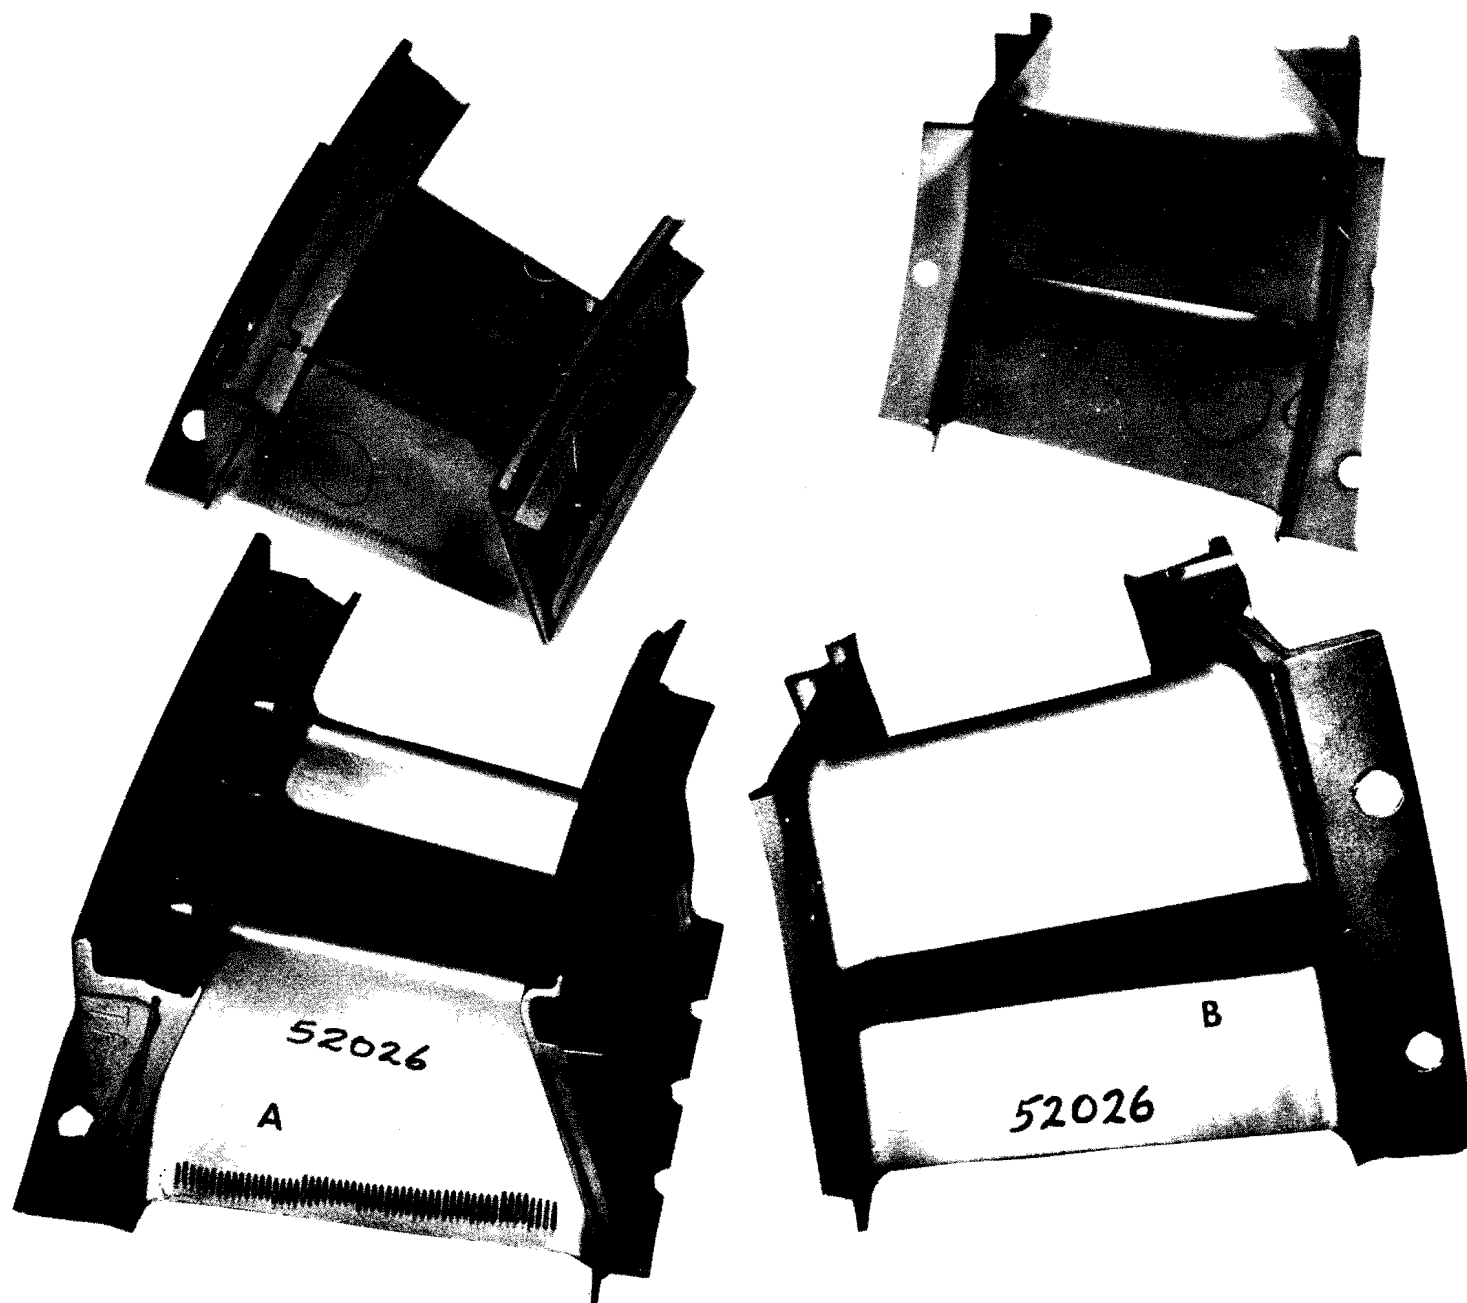
Figure 10. Stage 2 HPTV, S/N 52026, Before ADH Repair and After 1000 Cycle Engine Test. Areas A and B Examined Metallographically.
